# ANATOMY OF A BUILDING ENVELOPE FAILURE

Presented by Ray Ramos | July 2021  
*BE105-1, 1 LU / HSW*

# Presentation Introduction – Neurology Clinic, *Greenville, NC*

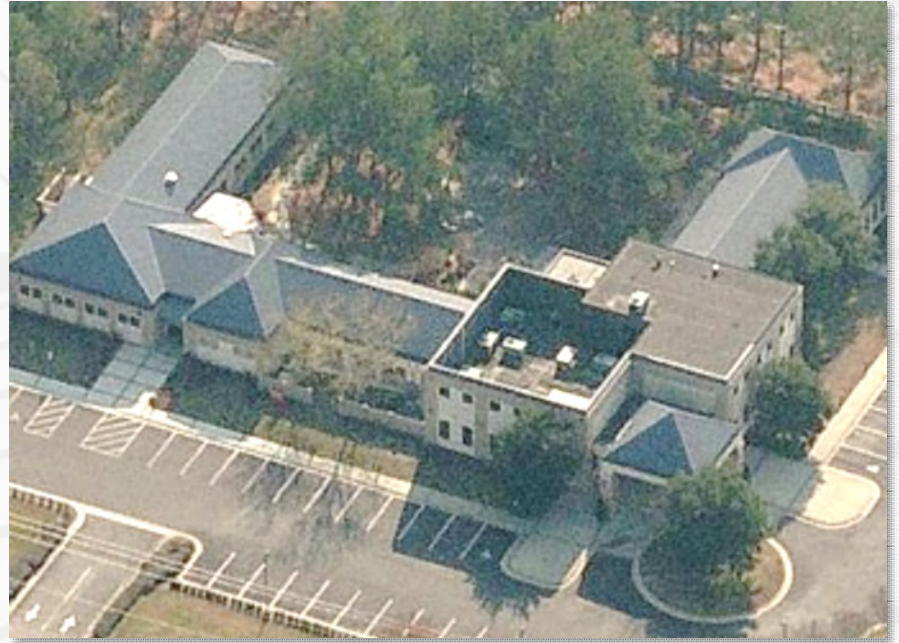
**Owner complains of peeling wall paper at windows, water leaks and mold. Unsure if they should replace the roof or if they should replace windows?**

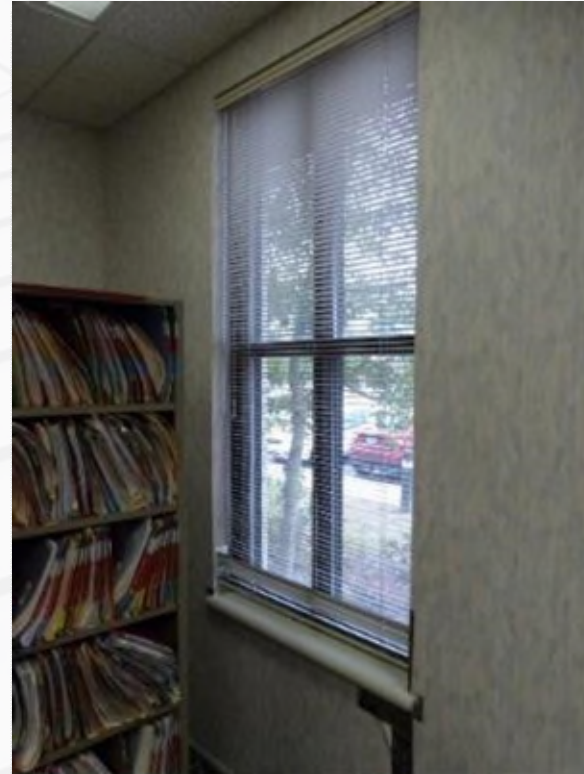
### 3. Conditions / Symptoms – First & Second Floor Windows

**First Floor  
Directly Below**

**Second Floor**

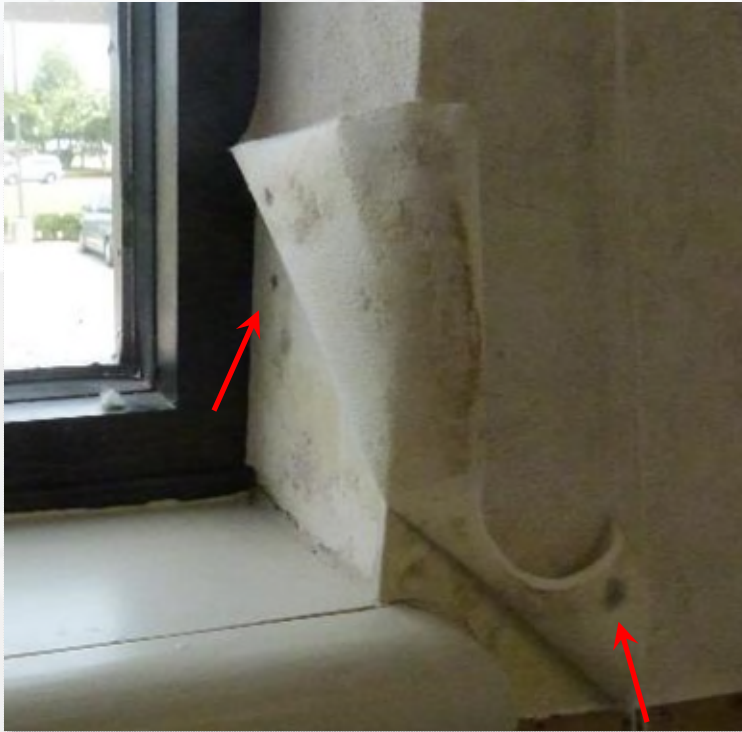
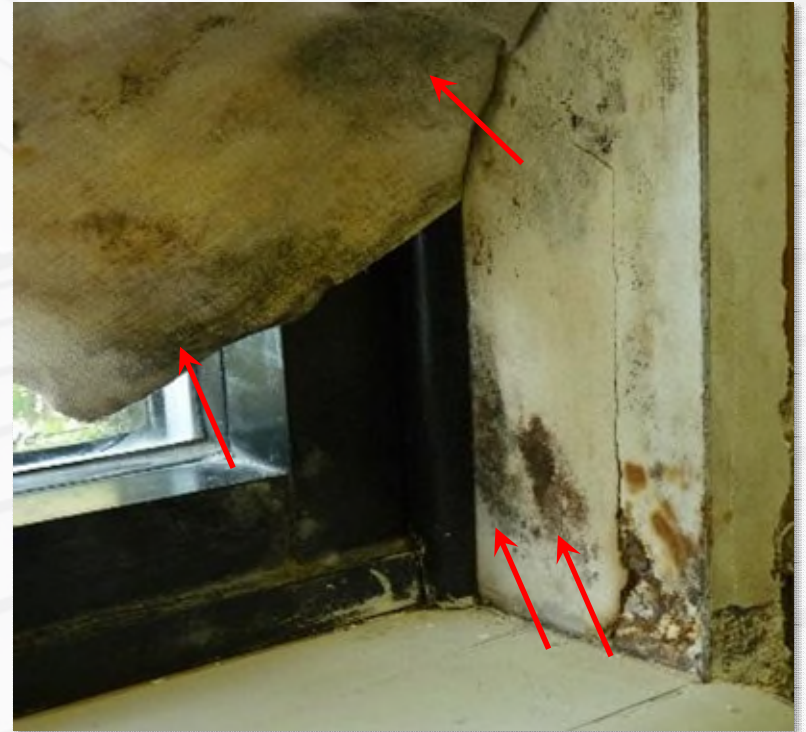
### 3. Conditions / Symptoms – Concern for Mold

- No wallpaper on exterior walls of buildings in southern climate
- Eliminate liquid water, Reduce Indoor Rh to 30% - 60%
- More on Mold: <https://www.epa.gov/mold/how-use-mold-course>

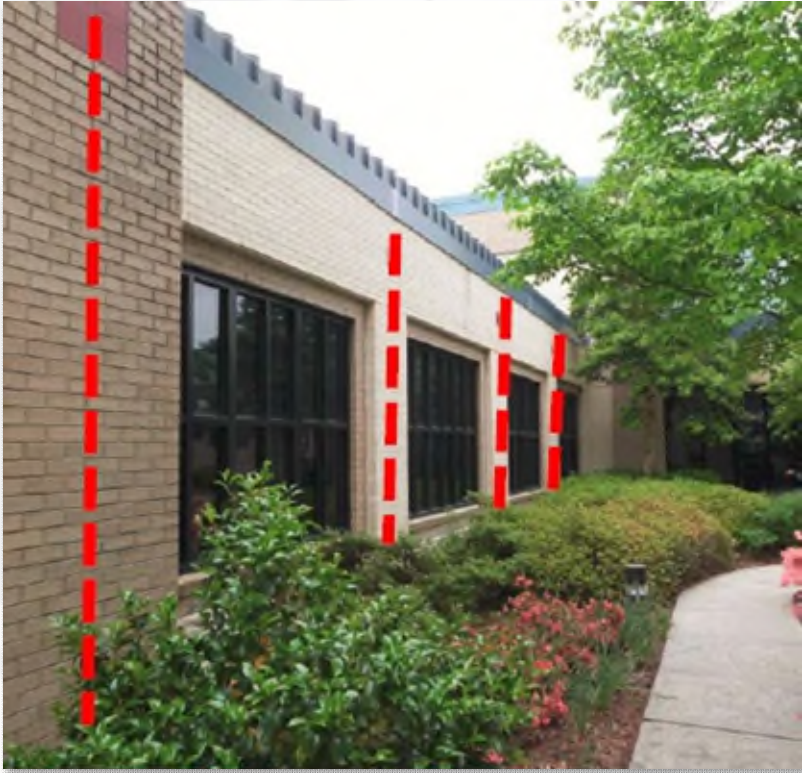
**Office Wing**

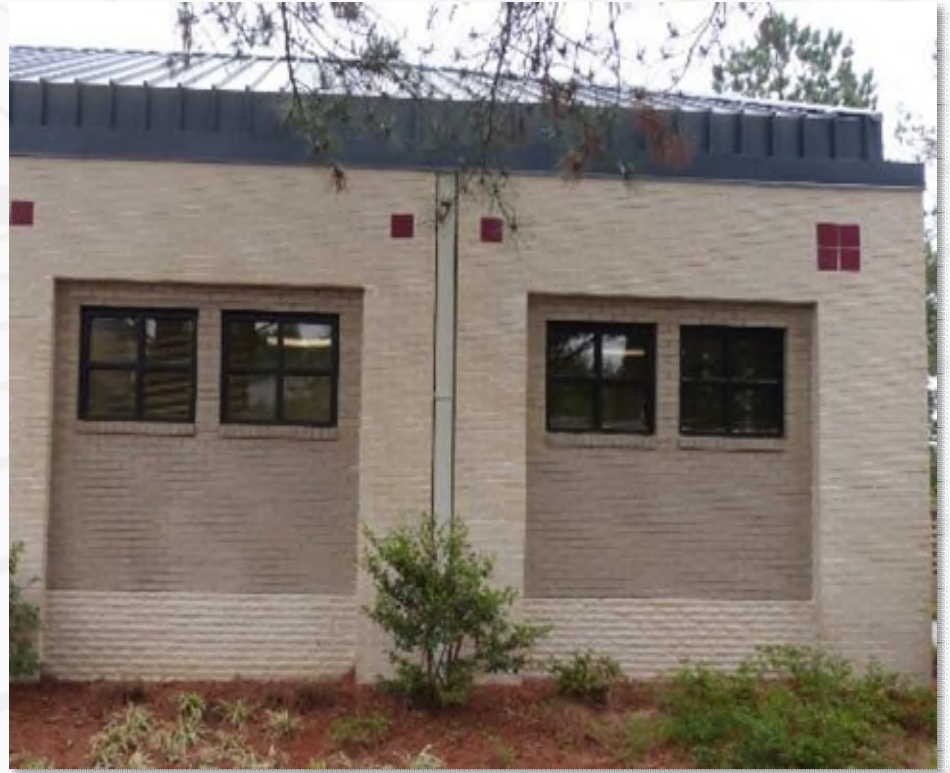
**Exam Room Wing**

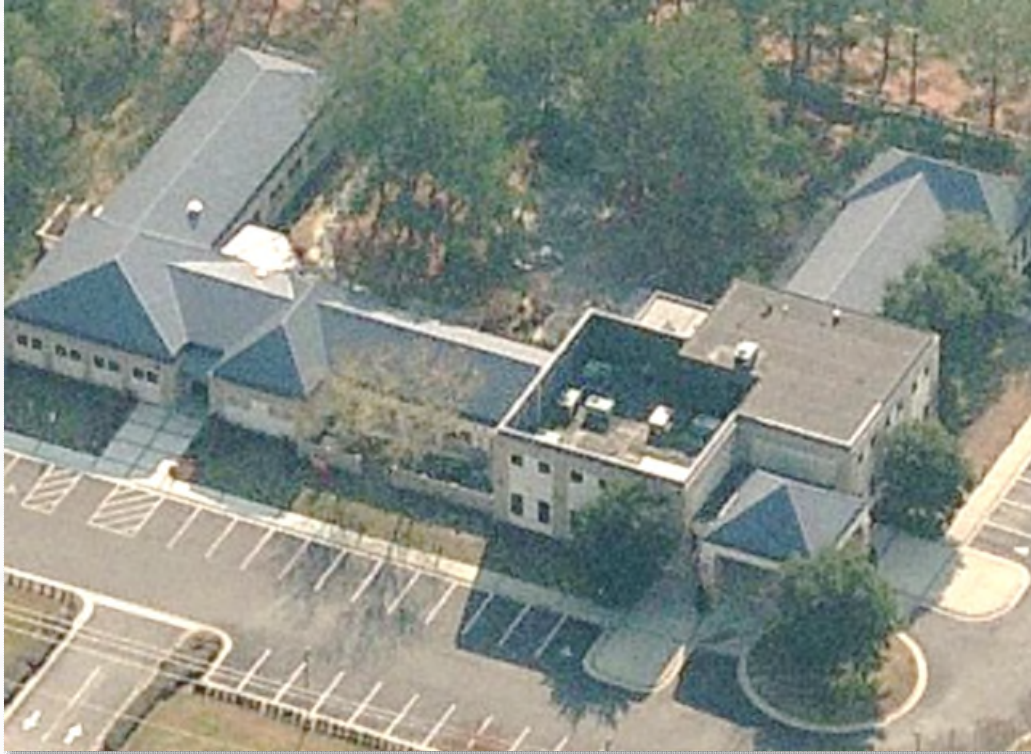
**Original Complaint** - Owner complains of peeling wallpaper at windows, and water leaks. Unsure if they should replace the roof or if they should replace windows?

## 1. Windows:

- Sill Pans are defective, missing end dams and sloped to allow water to drain into the building.
- Window Construction is defective, missing sealant and internal water diverters.
- Primary cause for silver tape at window corners.

## 2. Masonry:

- Through wall flashing is missing above & below windows.
- Through wall flashing which is present has no end dams.
- Lintels are rusted and covered by sheet metal.
- Mortar bridging.
- Weep holes above grade sealed & covered by mulch at grade.

## 3. Roof:

- Gutters Leak into the building.
- Details are open to the weather including ridge.

- Better Option
- New windows
- Reconstruct the gutter
- New wall flashing above and below windows
- Minor Roof Repairs
- Remove wallpaper @ ext. walls

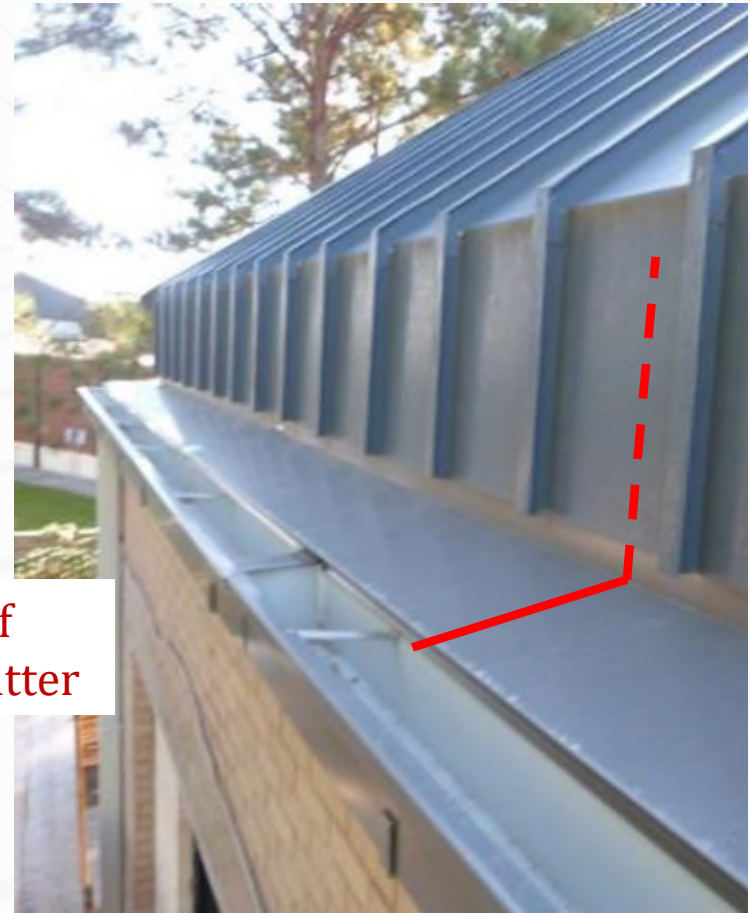
# 6. Resolution – Gutter Reconstruction

Original

Reconstruction In-Depth

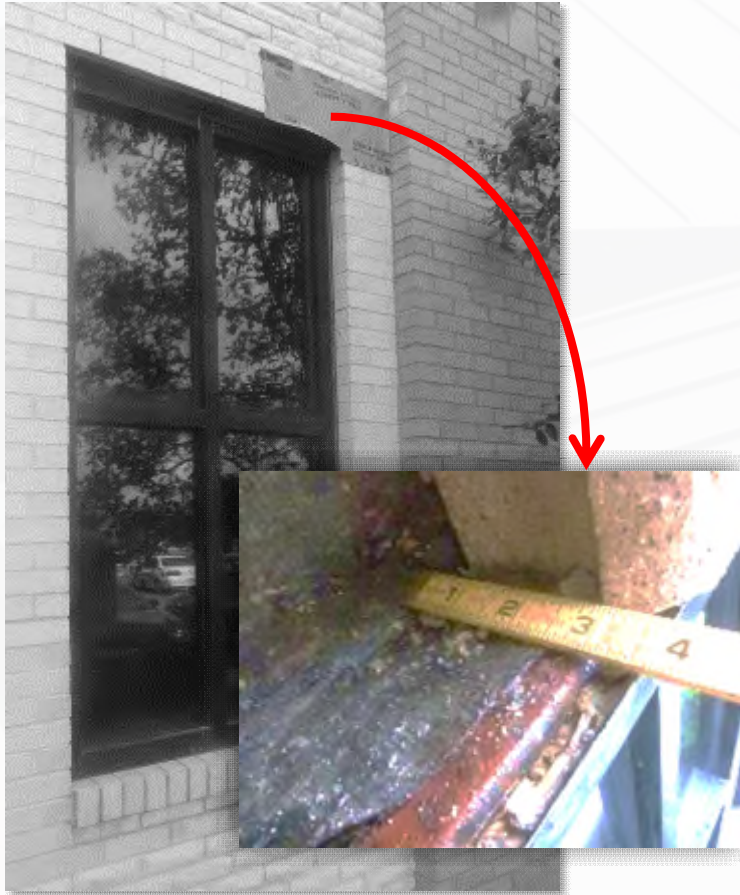
**Original**

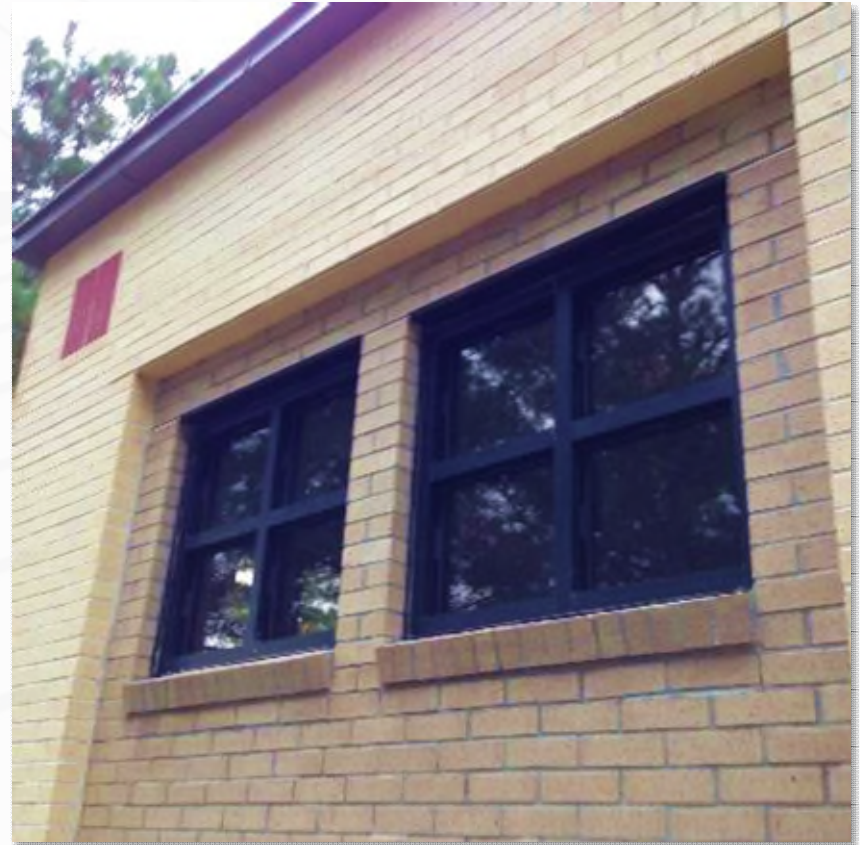
**Reconstruction**

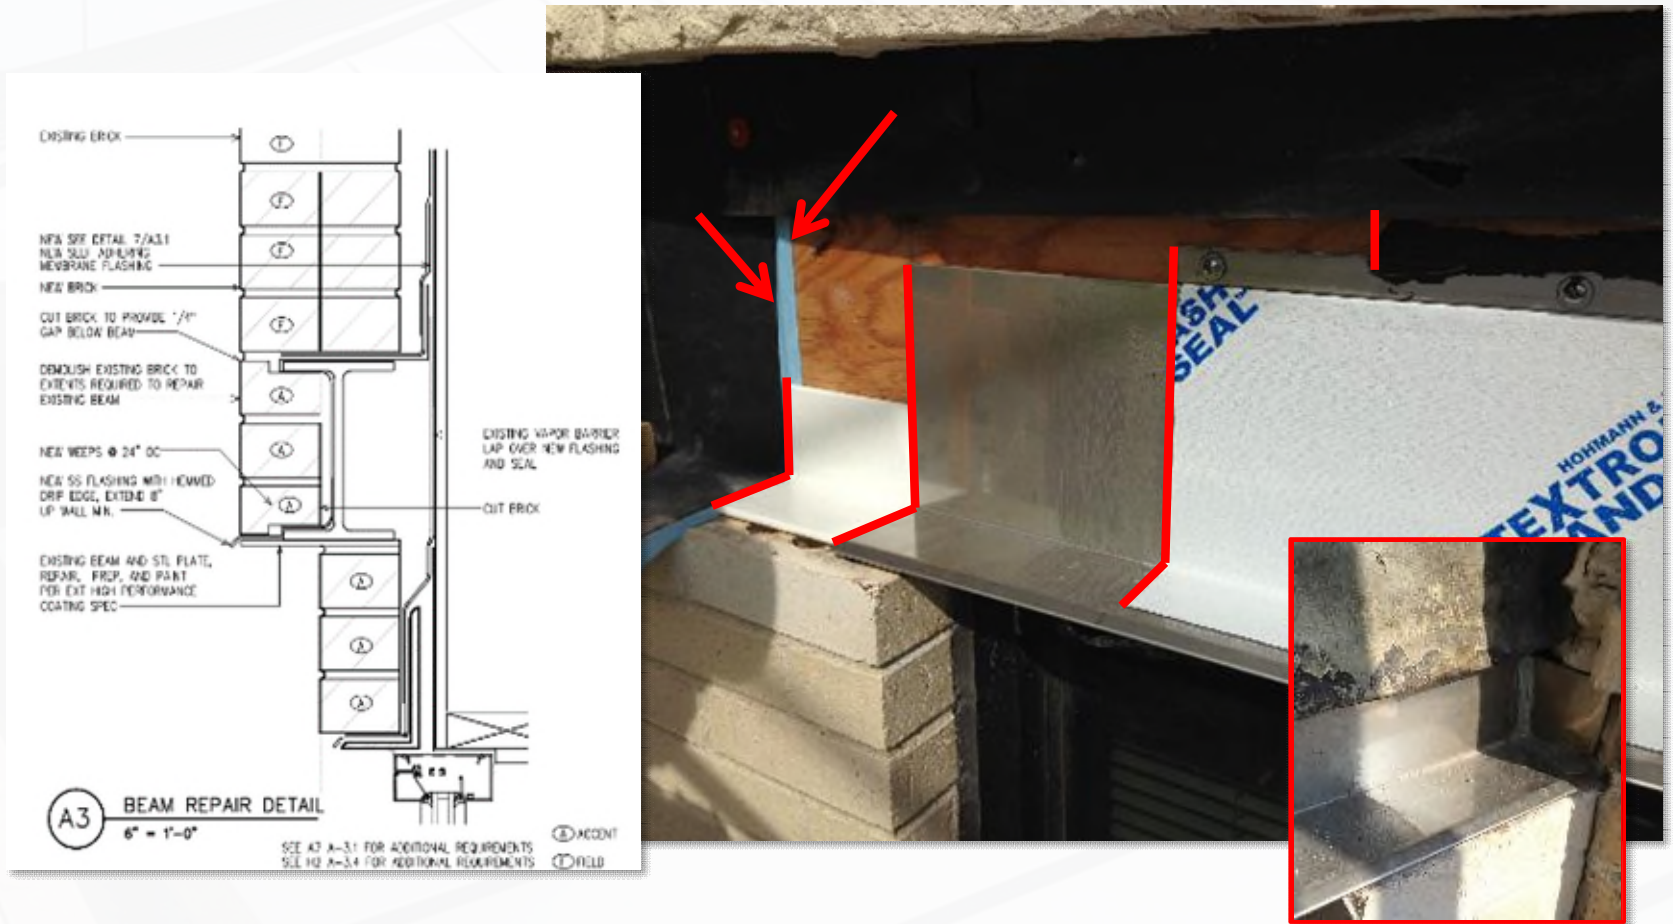
## Reconstruction In-Depth

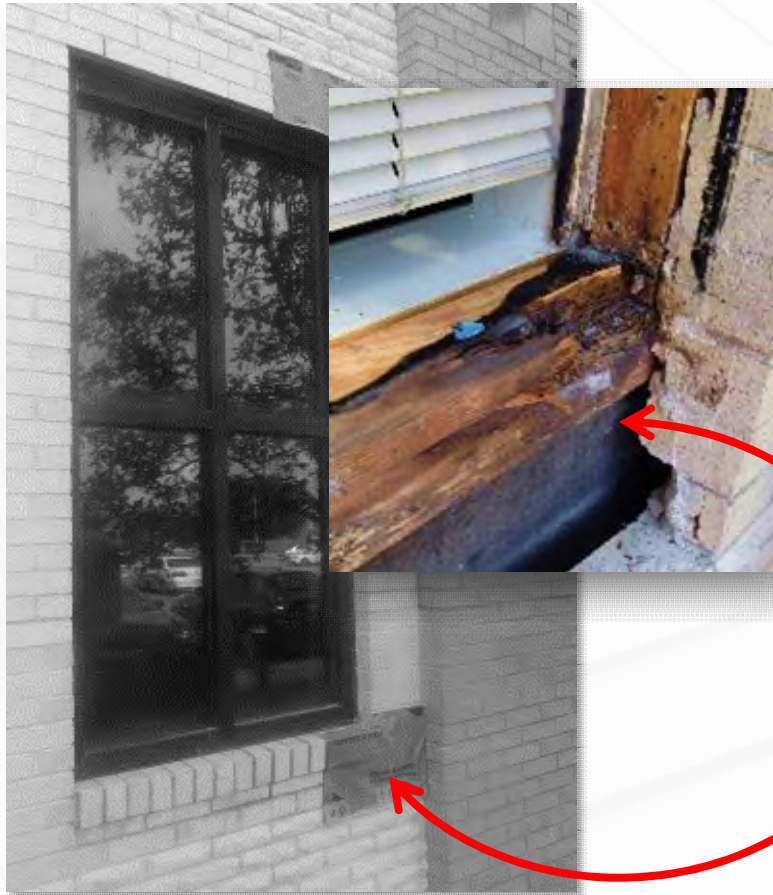
**Original**

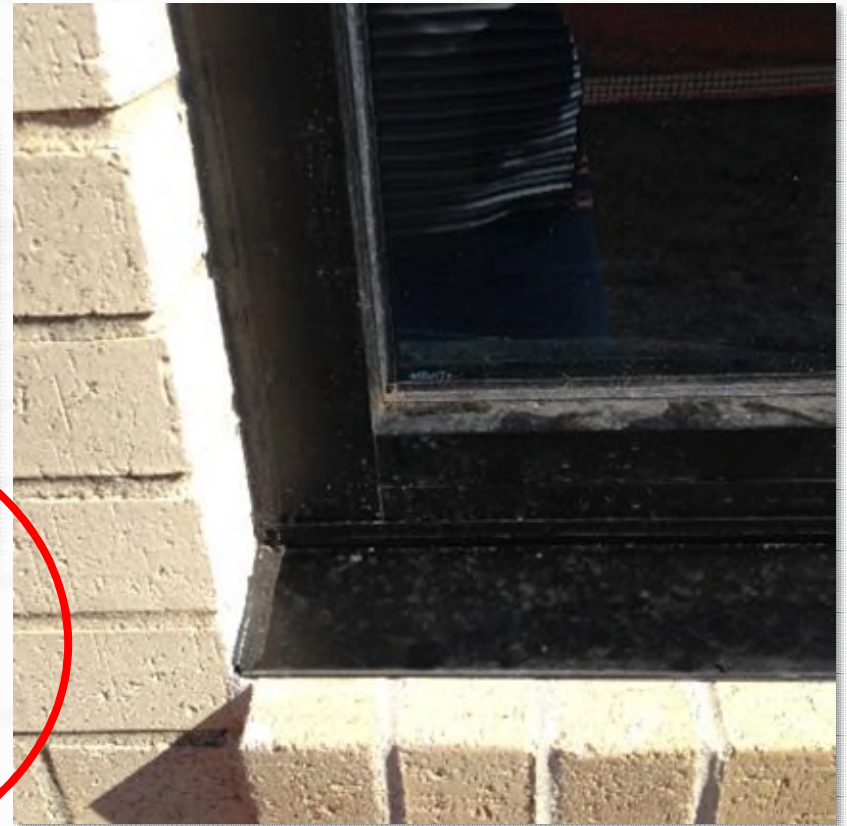
**Reconstruction**

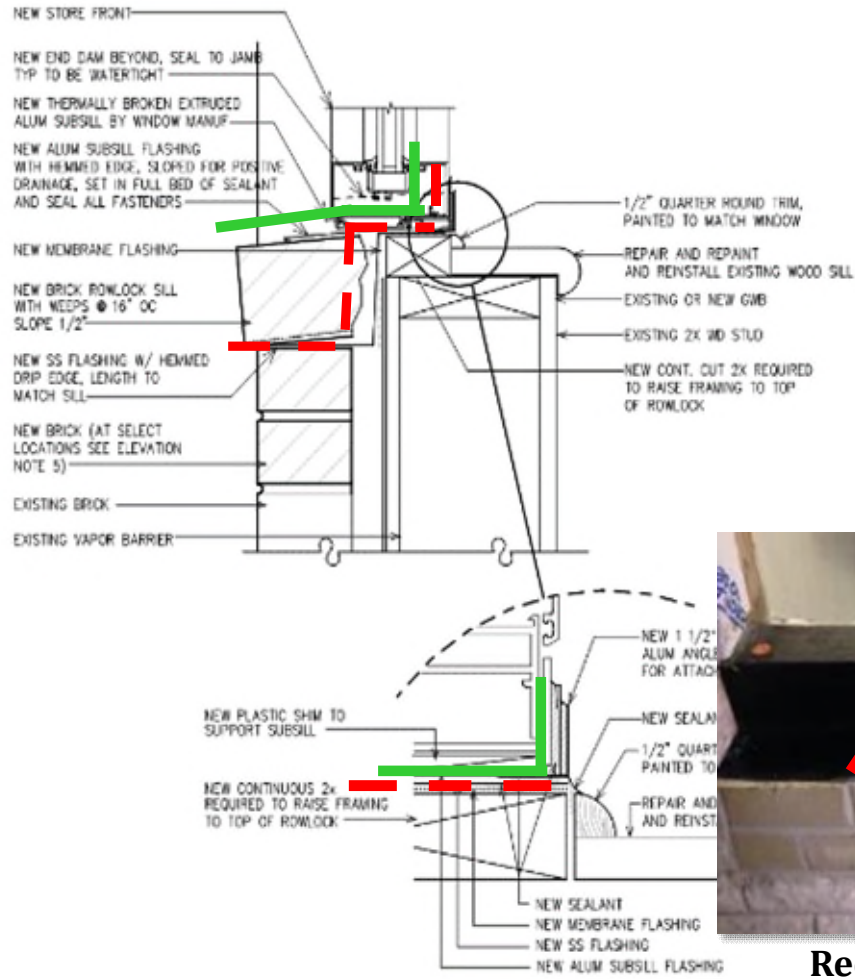
**Reconstruction In-Depth**

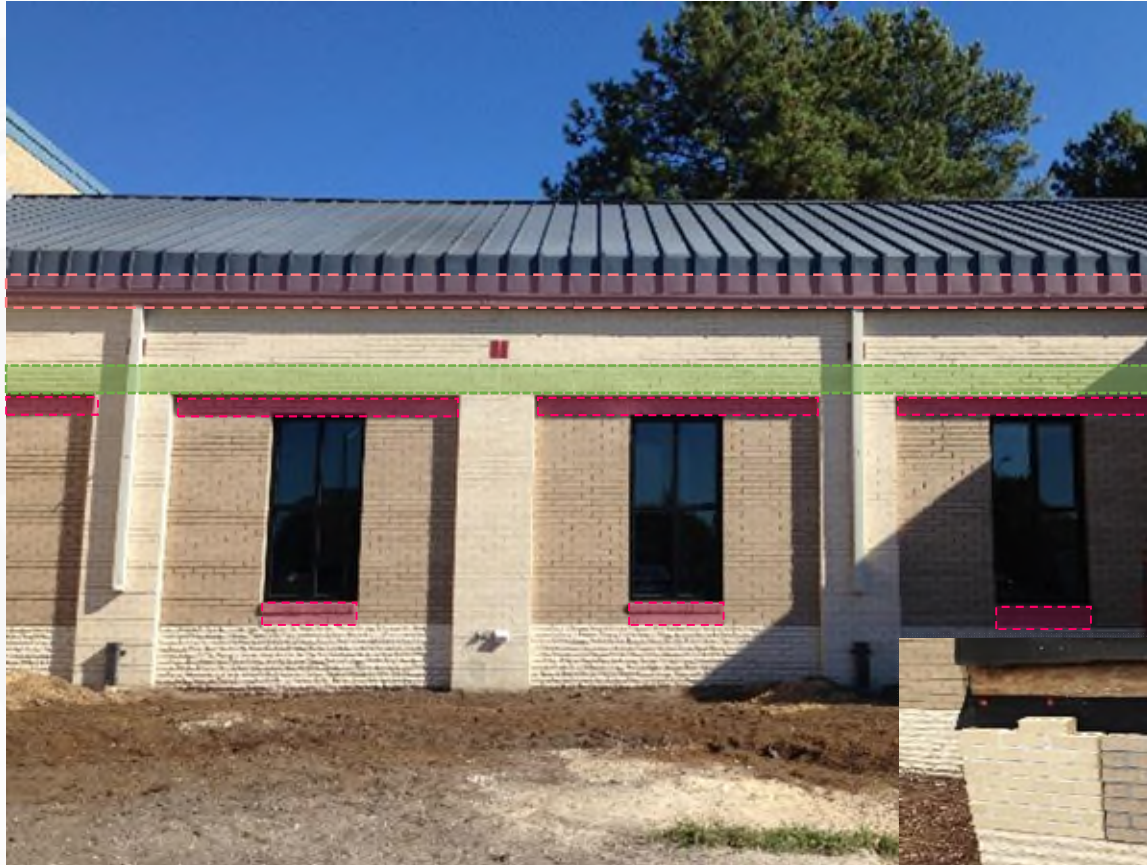
1. Addition of flashing reduces the actual window opening, resulting in a slightly smaller window.
2. Designing repairs to match consistently with existing elevation.
3. Removal of site trees created additional light/ glare at interior.
4. Matching masonry

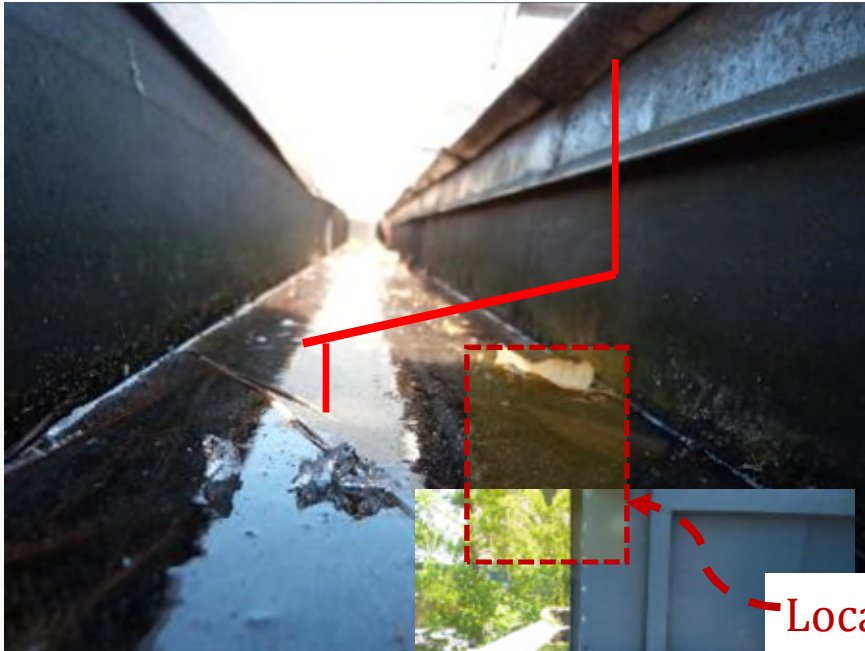
**Original**

Location of original gutter

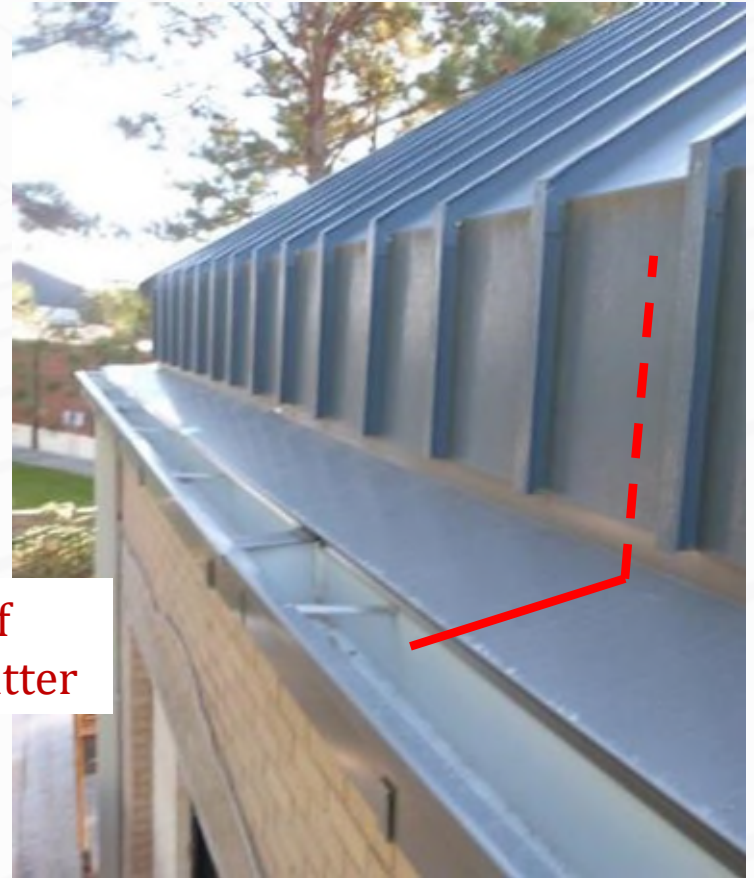
**Reconstruction In-Depth**

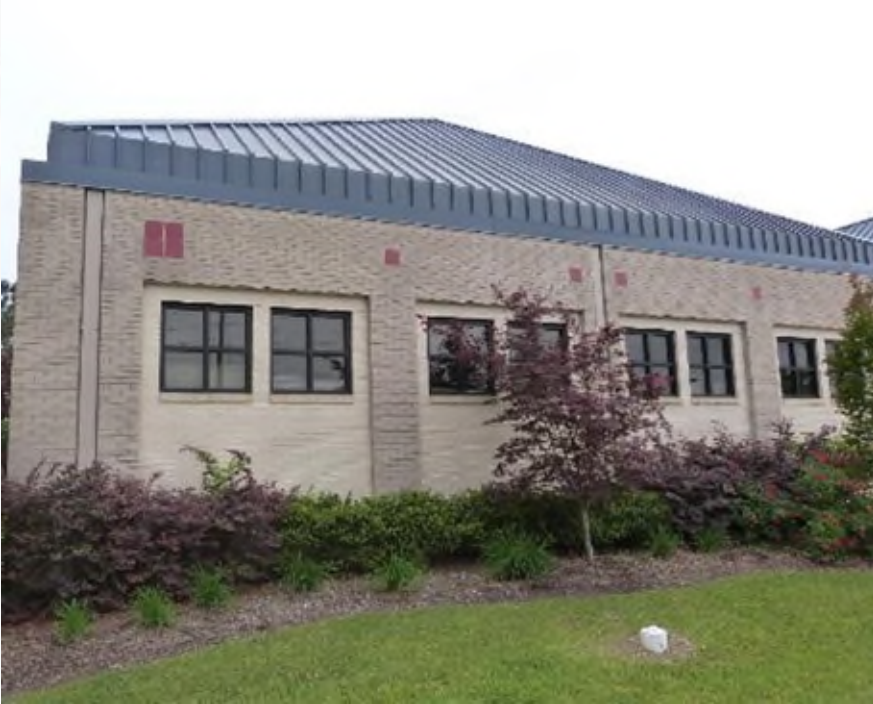
**Original**

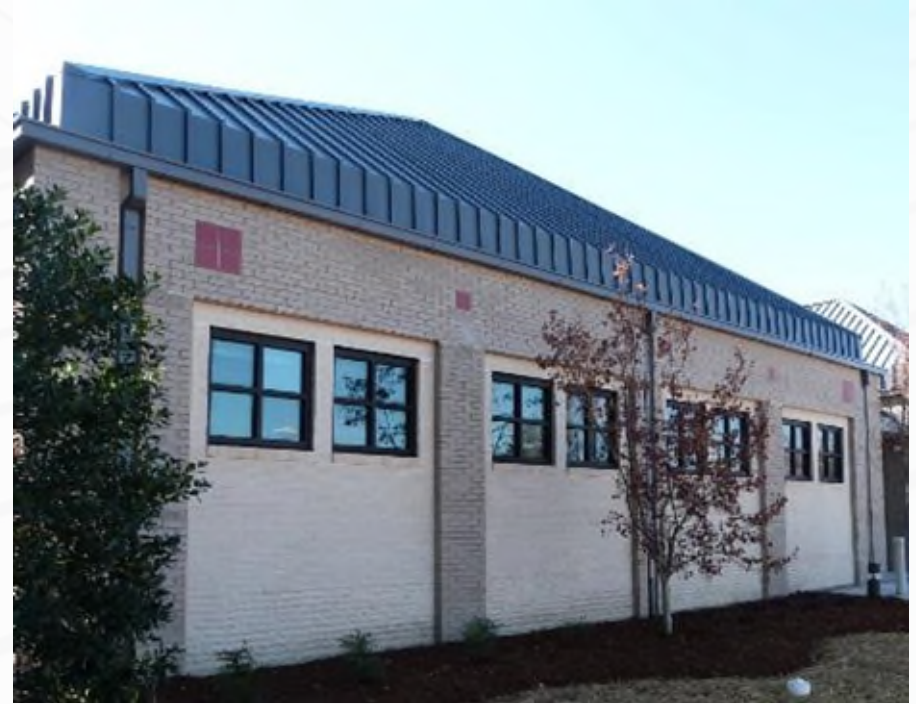
**Reconstruction**

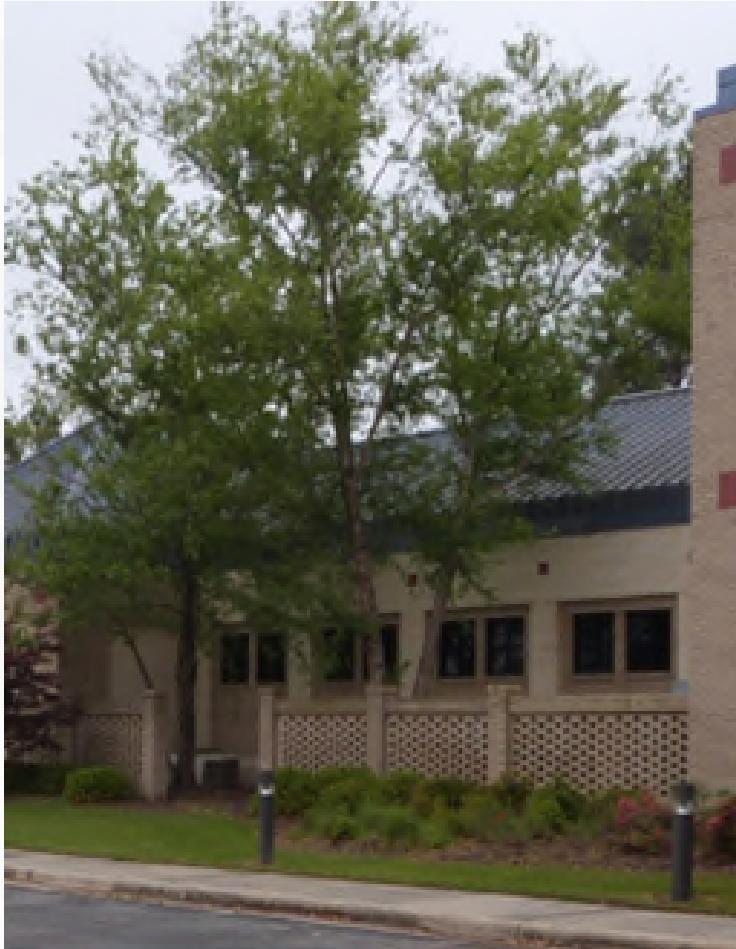
**Original**

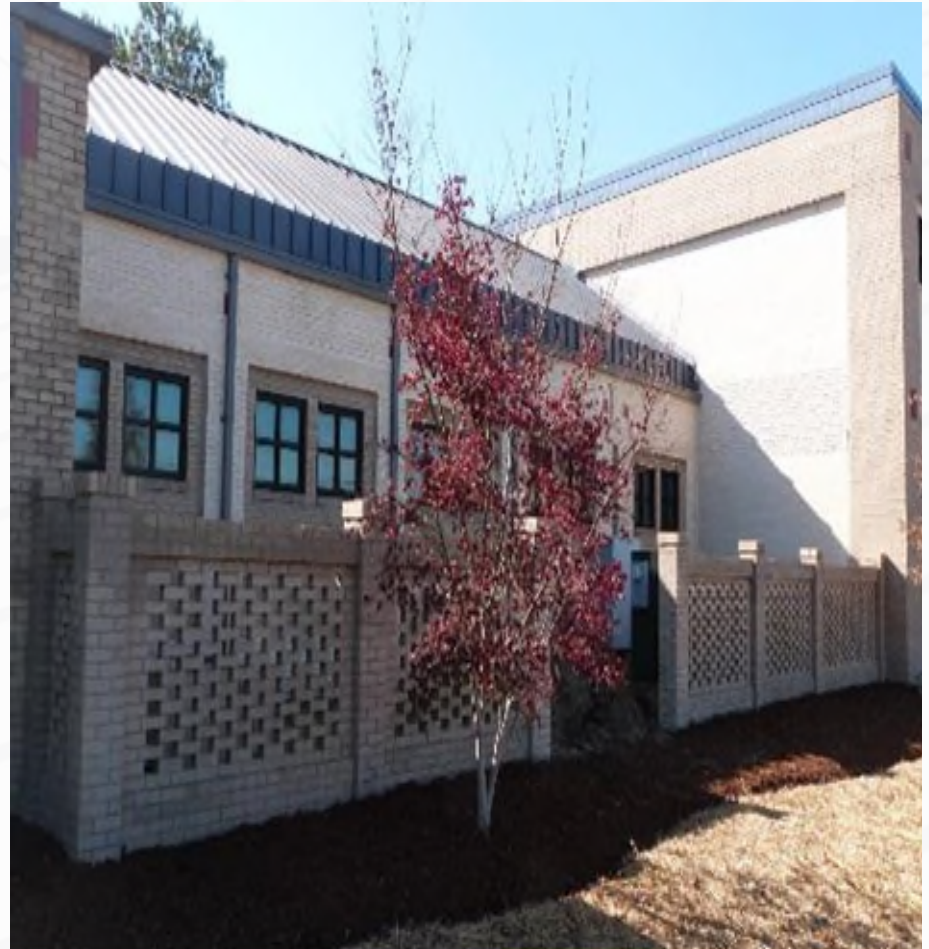
**Reconstruction**

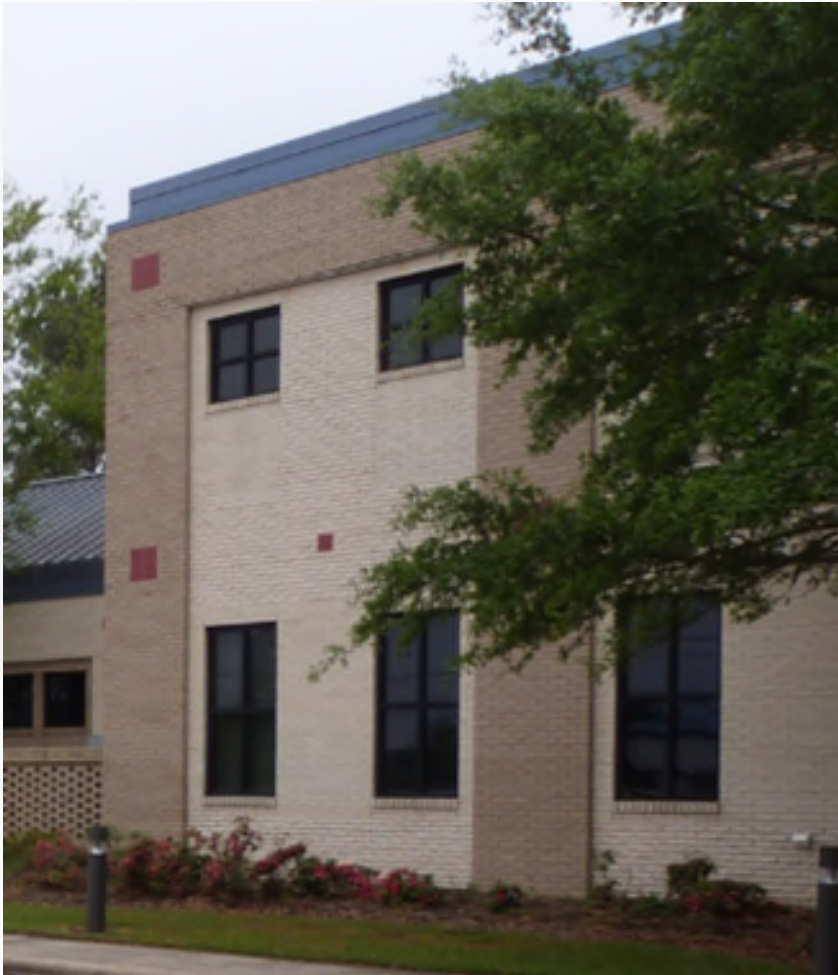
**Original**

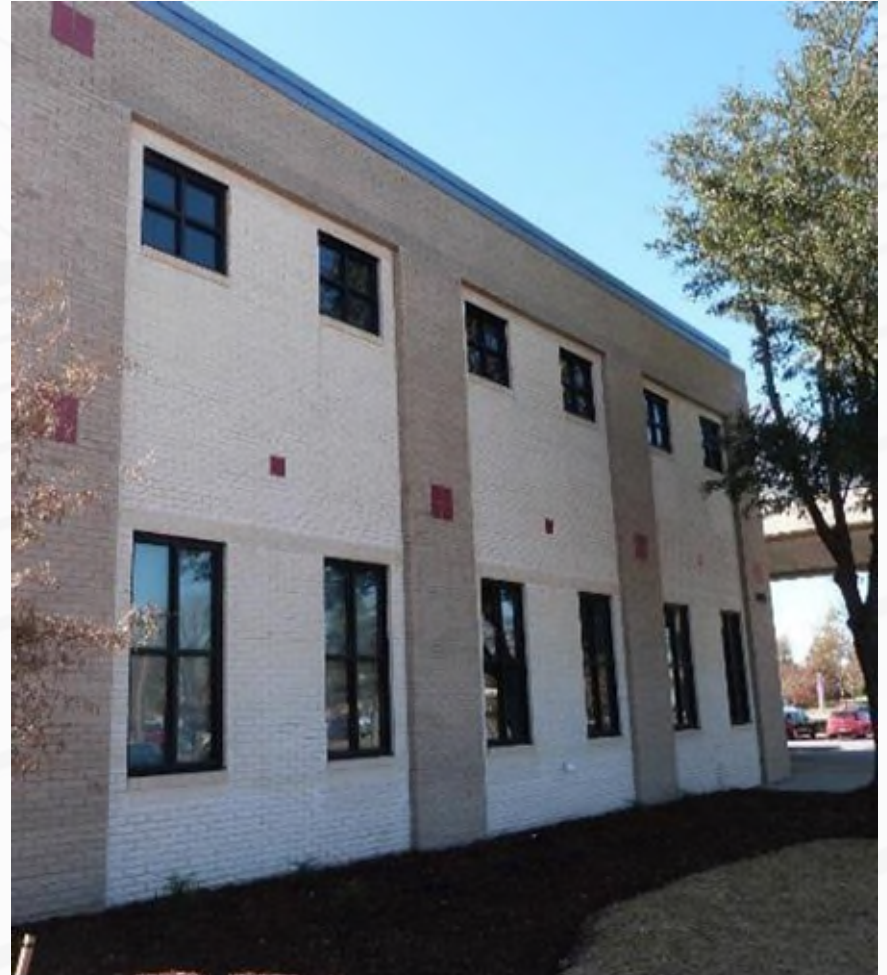
**Reconstruction**

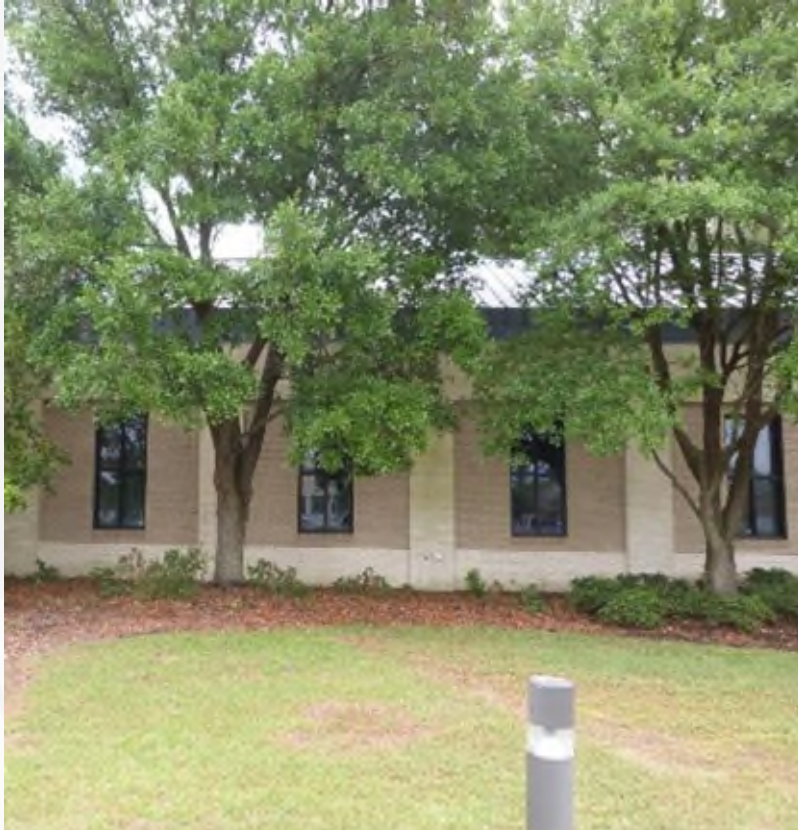
**Original**

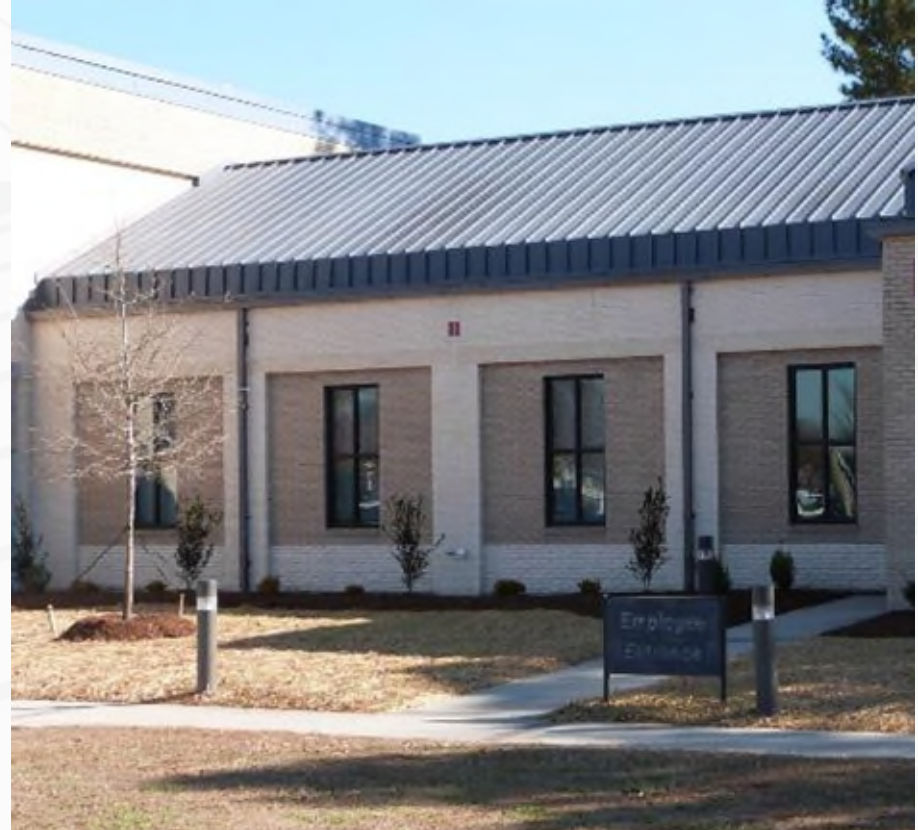
**Reconstruction**
